# Weekly Construction Report

## Hatchery Creek Design/Build Project

<b>Two Weeks:</b>	<b>October 19 - November 1, 2014</b>	<b>Project No:</b>	<b>1305</b>
<b>Rain Days/Weather Conditions:</b>	Rained 0.3" on Oct. 23 <sup>rd</sup> , 0.5" on Oct. 28 <sup>th</sup> , & .1" on Oct. 31 <sup>st</sup> . (Burkesville gauge).		
<b>Personnel on-site:</b>	<i>EcoGro/Ridgewater:</i> John Arthur, Tony Berry, Tom Cutter, Eric Dawalt, Jon Linder, Chad Relinski, & Brad Redmon. <i>Stantec:</i> Oakes Routt (Oct. 20-21 for dye tracing, Oct. 27 <sup>th</sup> for stakeout)		
<b>Equipment on-site:</b>	Komatsu PC 160 w/ hyd. thumb, PC 360 w/ hyd. thumb, Terex TA27, Bobcat T300		
<b>Material deliveries to project site:</b>	<ul style="list-style-type: none"> <li>N/A</li> </ul>		
<b>Work performed first week (Oct. 19-25):</b>	<ul style="list-style-type: none"> <li>Removed wet, unsuitable soil in ravine in order to be ready to place compacted clay fill. Placed unsuitable soil in between old "rip rap" channel and temporary diversion channel to dry out.</li> <li>Added another 40 CY of 18"+ D50 rock to temporary diversion rock chute to further stabilize the ravine bank toe.</li> <li>Found "sinkhole" on Monday Oct

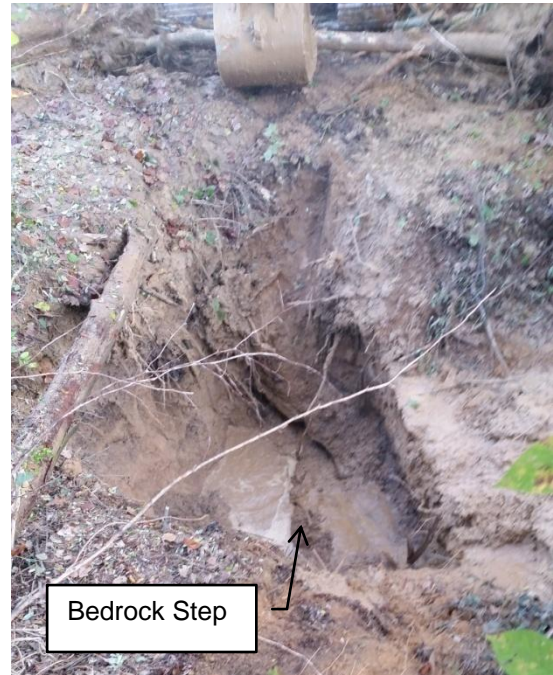
***On left: "Sinkhole" in ravine pool (picture taken looking upstream at ~Sta. 303+80). On right: Bedrock step at "sinkhole" location in ravine after being excavated (picture taken from left bank looking across ravine).***

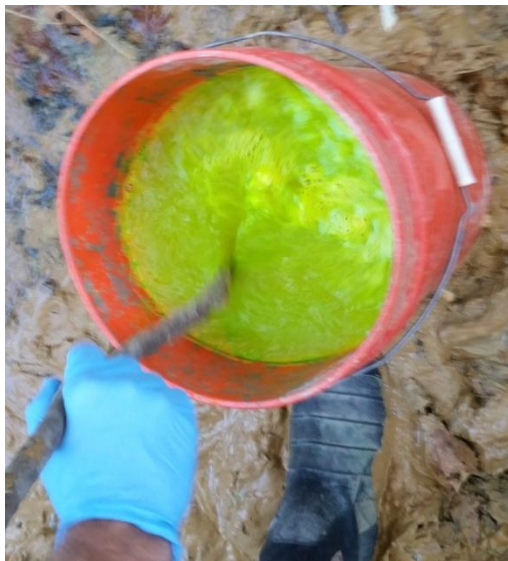
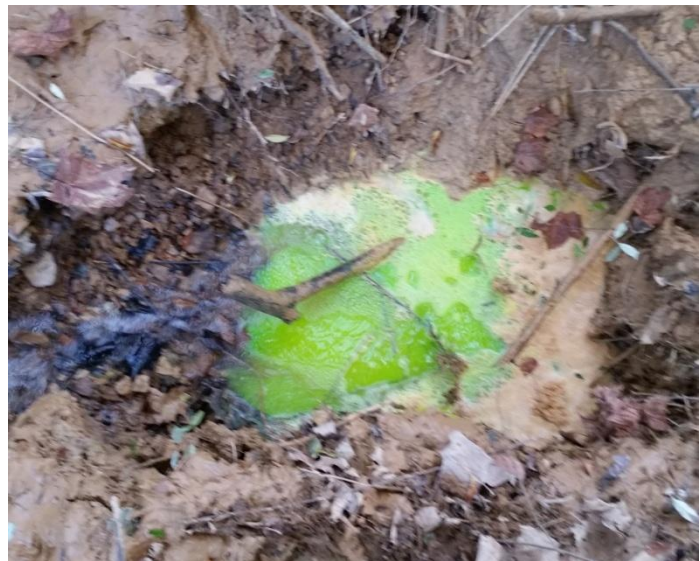
***Non-toxic dye was mixed (on left) and added to the "sinkhole" (on right) in order to locate where the groundwater resurfaces. The dye resurfaced in the ravine downstream of the compacted clay core work area over 12 hours later.***

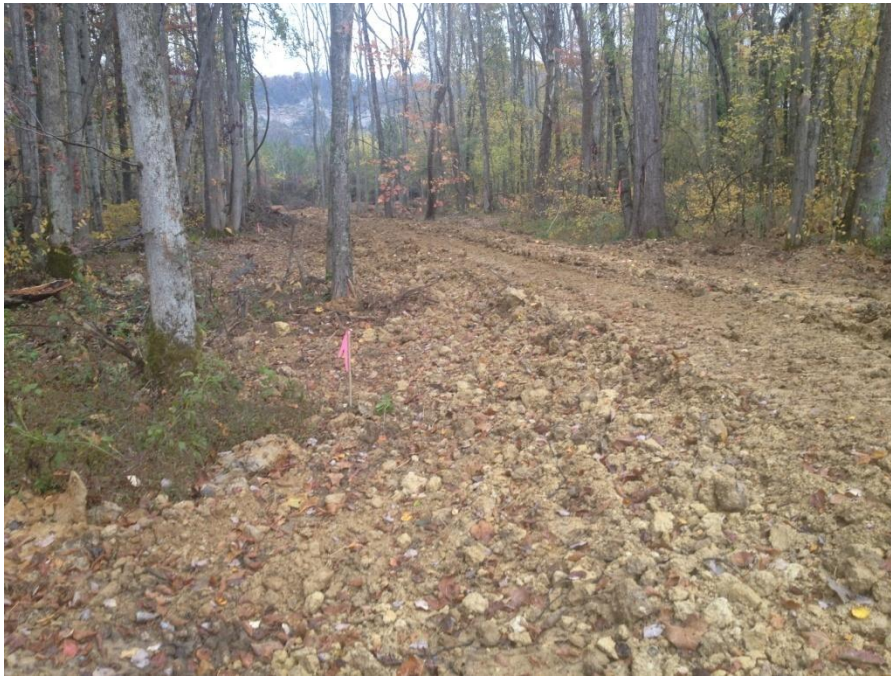
***The first two feet of the floodplain berm was installed (~Sta. 205+00 to 211+00).***

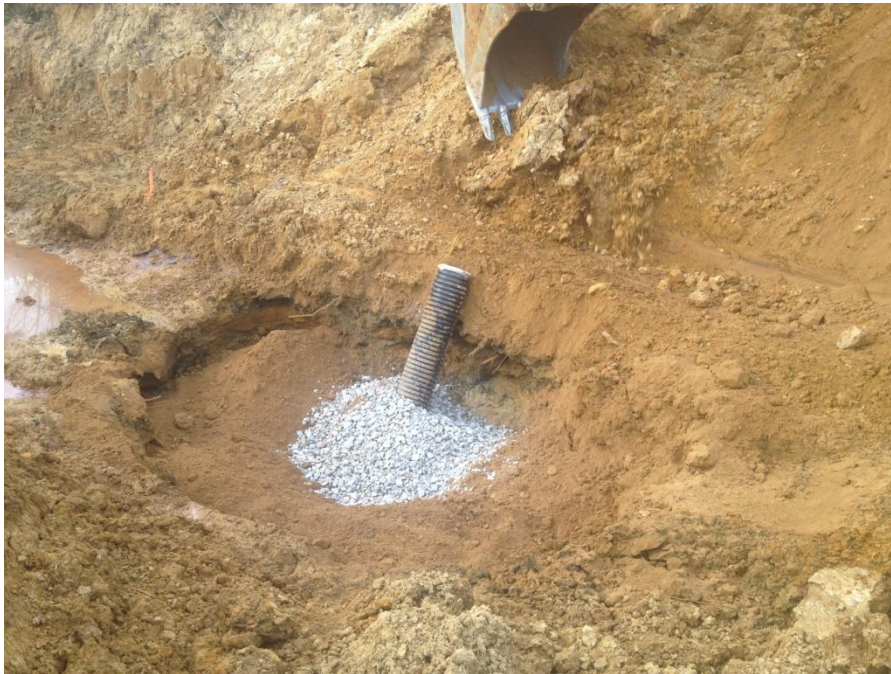
***Installing dewatering well upstream of compacted clay core to lower groundwater levels in order to extend the compacted clay core down to bedrock (~Sta. 106+40).***

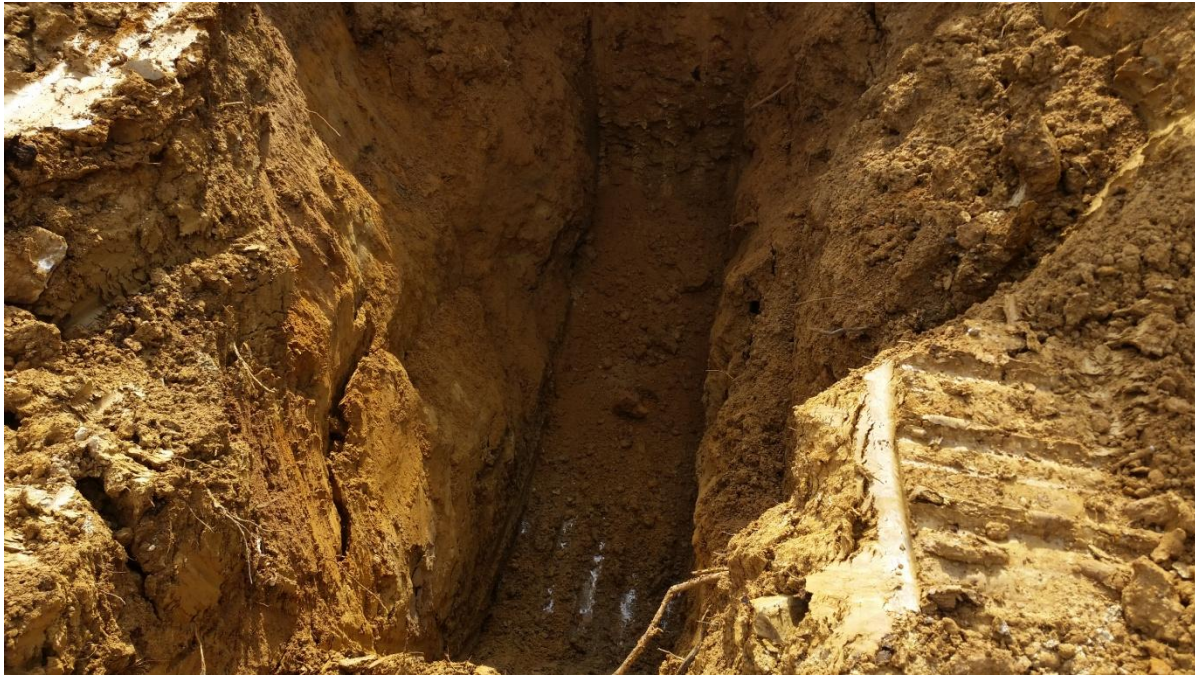
***Trench excavated across ravine to bedrock in order to extend compacted clay core to bedrock (~Sta. 106+40, ~ 25' LT). Clay was then installed and compacted in the trench with an excavator.***

<b>Work performed second week (Oct. 26-Nov. 1):</b>	<ul style="list-style-type: none"> <li>Extended the compacted clay core crossing the ravine by excavating 5'+ wide trench with excavator through previously installed clay core (bottom elevation was ~567') down to bedrock (~elevation 560') to disrupt any permeable layers.               <ul style="list-style-type: none"> <li>We did find a few pockets of creek gravel, but it was not a continuous layer.</li> <li>Clay was installed and compacted with an excavator bucket up to ~elevation 572'. Above this elevation, the compacted clay core was built 10'+ wide and compacted in ~8" lifts using a sheepsfoot compactor. It was built up to ~elevation 578' so far.</li> </ul> </li> </ul>

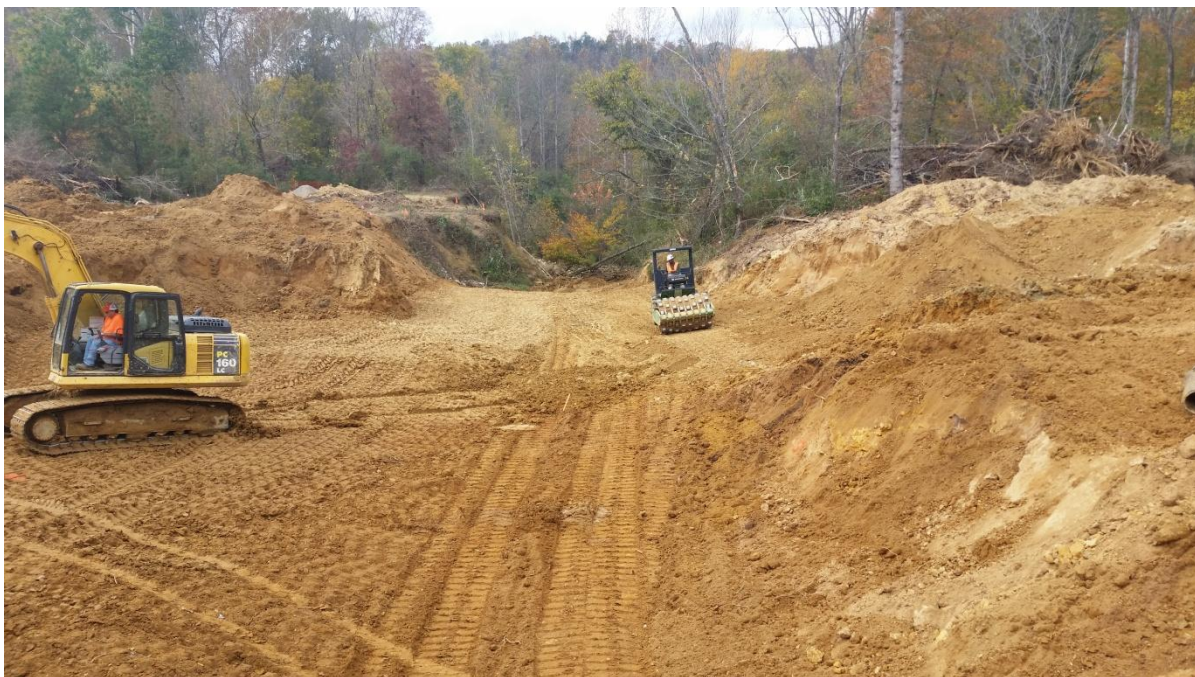
***Compacted clay core being installed with sheepsfoot compactor up to elevation 578' (picture taken from bridge looking downstream through the ravine at ~RT Sta. 106+40).***

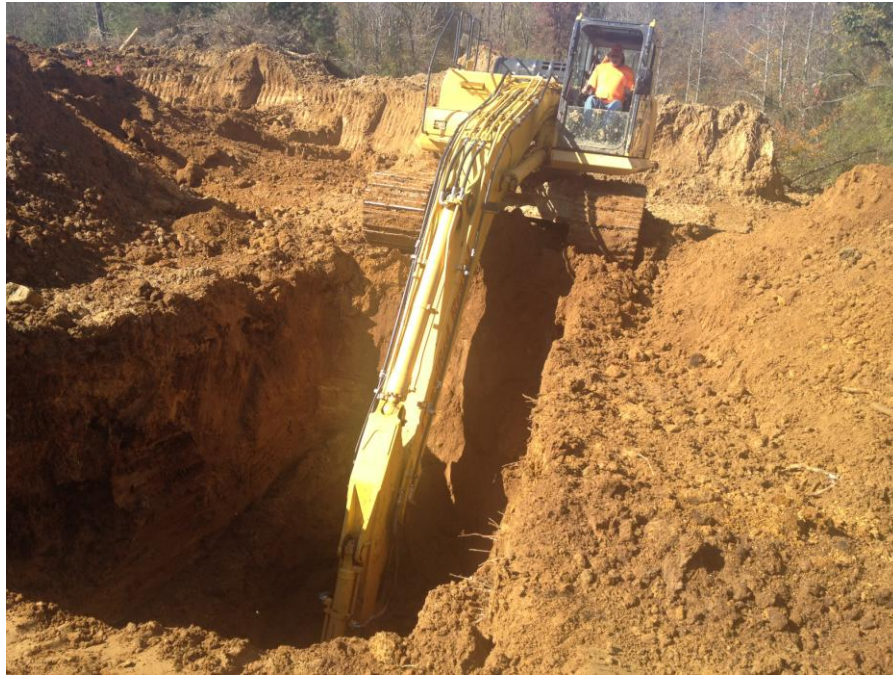
***Excavating trench through the bottom section of the "U"-shaped compacted clay core located at the proposed migration barrier.***

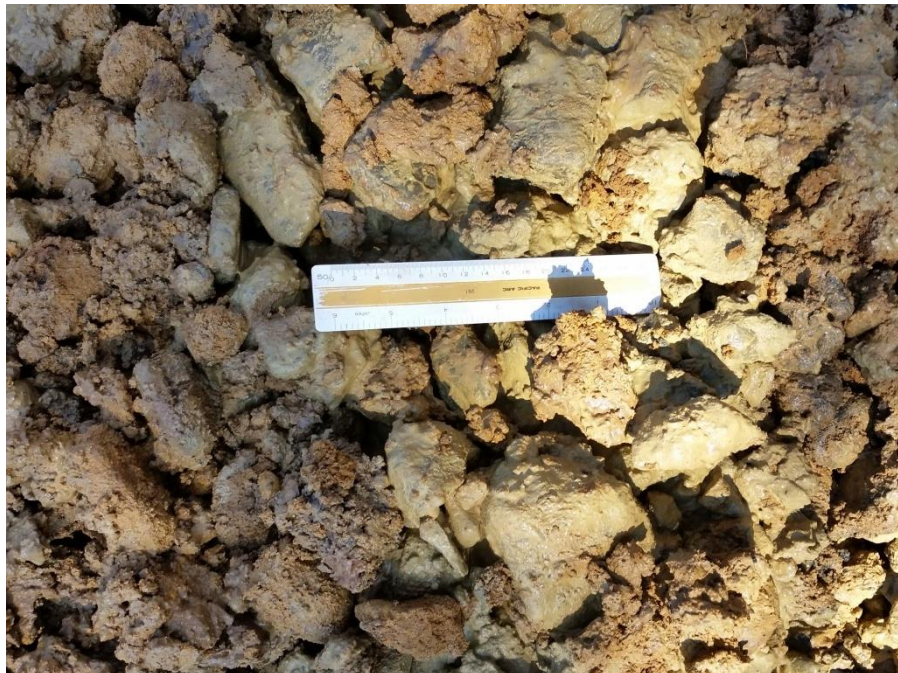
***Gravel near bedrock surface that was excavated from the trench of the "U"-shaped compacted clay core located at the proposed migration barrier. Six-inch scale is shown for reference.***

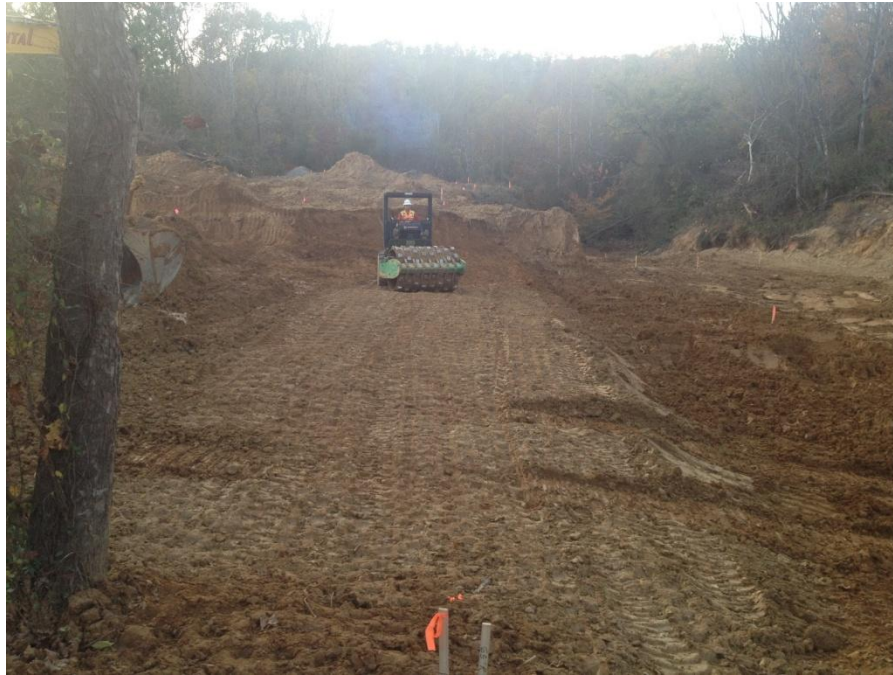
***Compacted clay core being installed at location of proposed migration barrier (picture taken from gravel trail leading to bridge at ~Sta. 105+85). The bottom of the "U" is shown, with the two sides extending to the left of the picture.***
